Property Inspection Report

Report Number: 10428

10428 Wilson Glen Drive
Charlotte, North Carolina 28214

Date of Inspection: Saturday, June 9, 2018

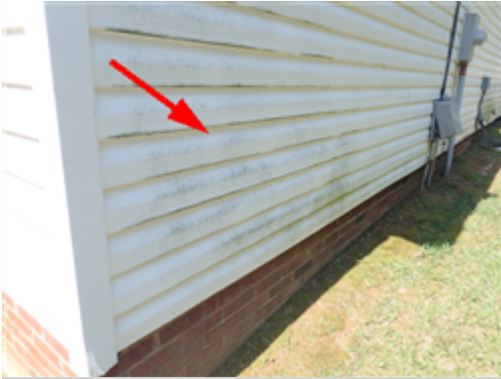
(B1 - 1.3) Main House

The exterior rear of the home in several areas has mold growth on the vinyl siding. Mold growth can weaken vinyl over time recommend pressure washing of rear of home.

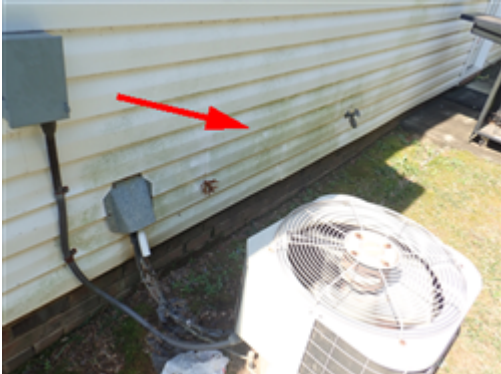
(B1 - 1.4) Main House

The exterior rear of the home in several areas has mold growth on the vinyl siding. Mold growth can weaken vinyl over time recommend pressure washing of rear of home.

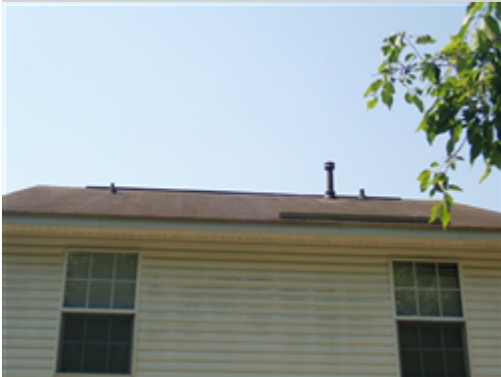
(B1 - 1.5) Main House

The exterior rear of the home in several areas has mold growth on the vinyl siding. Mold growth can weaken vinyl over time recommend pressure washing of rear of home.

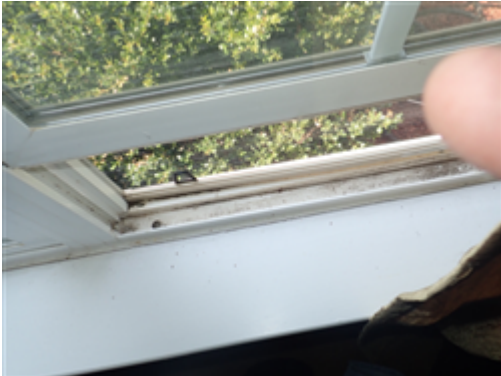
(B2 - 1.1) Windows

The sash spring were noted to be disconnected on left front windows in main front living area during the inspection. The sash springs assist in lifting and holding the window in place when it is opened. When the springs are disconnected or broken the window will not remain in the open position and can drop suddenly resulting in personal injury. Repair is needed to ensure proper function of the window. A general repair specialist or licensed general contractor should be consulted for evaluation and repair.

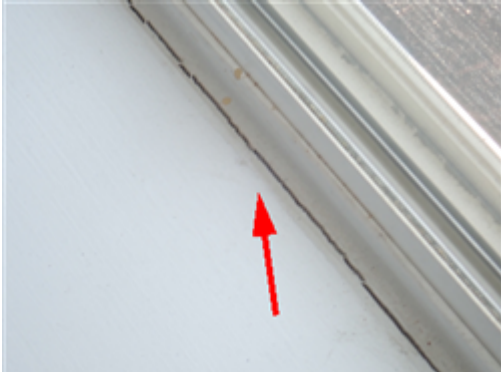
(B2 - 1.2) Windows

missing sealant / caulking from front window seal , overtime there will be movement from expansion and contraction to cause the openings, need to seal up the gaps to prevent any loss of air or any entry ways for insects to enter the home., recommend a general contractor be consulted to evaluate / repair .

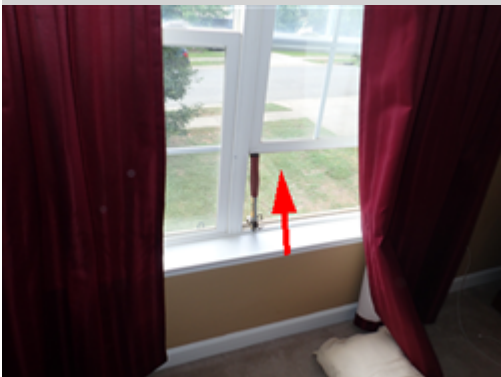
(B2 - 2.1) Windows

The sash spring were noted to be disconnected on both main windows in the master bedroom during the inspection. The sash springs assist in lifting and holding the window in place when it is opened. When the springs are disconnected or broken the window will not remain in the open position and can drop suddenly resulting in personal injury. Repair is needed to ensure proper function of the window. A general repair specialist or licensed general contractor should be consulted for evaluation and repair.

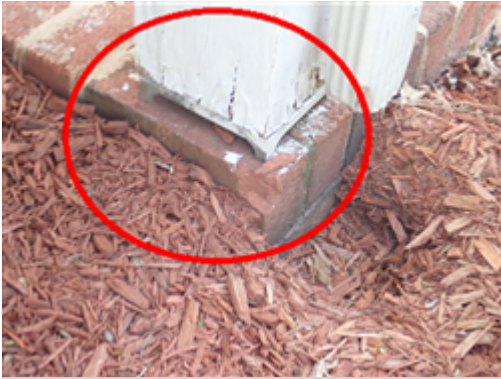
(B3 - 1.1) Porch

The columns that support the roof system of the home were noted to have areas of decay on both columns at the bottoms area. Columns and post are required to be stable to properly transfer loads to the foundation or footings. A licensed general contractor should be consulted for further evaluation, to determine the extent of the concern, and make necessary repairs.

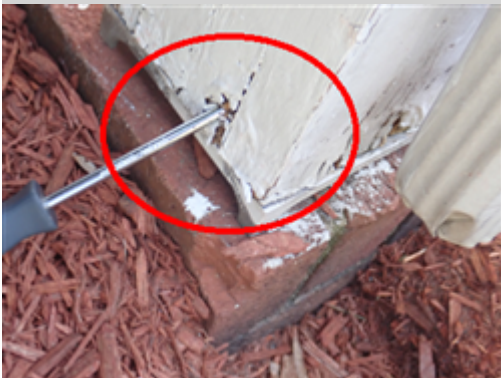
(B3 - 1.4) Porch

The columns that support the roof system of the home were noted to have areas of decay on both columns at the bottoms area. Columns and post are required to be stable to properly transfer loads to the foundation or footings. A licensed general contractor should be consulted for further evaluation, to determine the extent of the concern, and make necessary repairs.

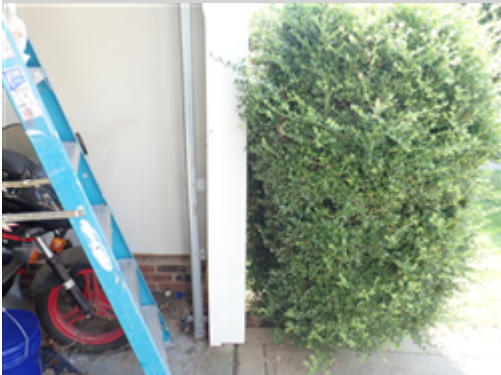
(B5 - 1.1) Vegetation

The vegetation around the perimeter of the home is over grown and blocks the air circulation around the home. A landscaping company should be consulted to correct the over growth.

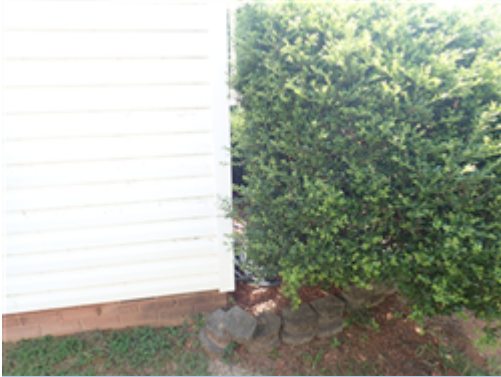
(B5 - 1.2) Vegetation

The vegetation around the perimeter of the home is over grown and blocks the air circulation around the home. A landscaping company should be consulted to correct the over growth.

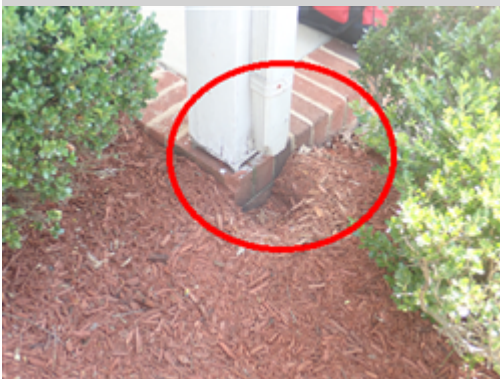
(C2 - 1.1) Main House

The gutter downspouts are not extended or piped to direct roof drainage away from the foundation. Direct drainage from the gutter system can result in direct water penetration into the foundation area and foundation deterioration. A licensed general contractor should be consulted for a complete evaluation and to make necessary repairs.

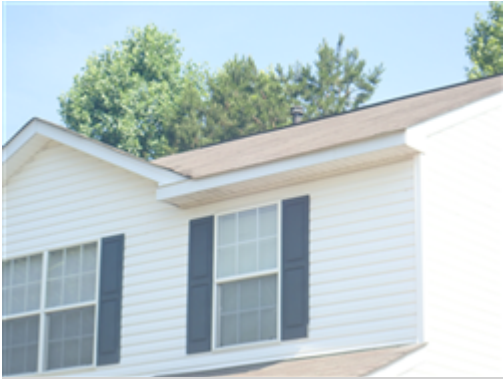
(C2 - 1.2) Main House

This home does not have a system such as gutters to control roof drainage. Direct drainage from the roof can result in direct water penetration into the foundation area and foundation deterioration. It is recommended that a gutter system with extended downspouts be installed to protect the wall cladding and foundation areas of the home. A licensed general contractor should be consulted for evaluation and installation.

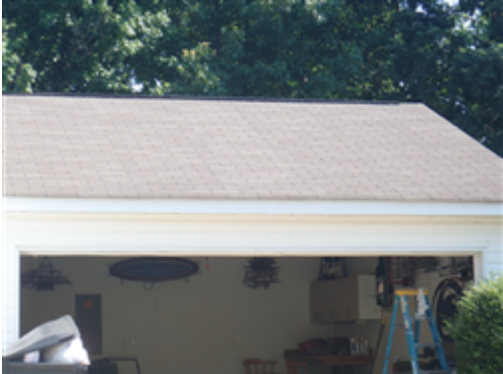
(C2 - 1.3) Main House

This home does not have a system such as gutters to control roof drainage. Direct drainage from the roof can result in direct water penetration into the foundation area and foundation deterioration. It is recommended that a gutter system with extended downspouts be installed to protect the wall cladding and foundation areas of the home. A licensed general contractor should be consulted for evaluation and installation.

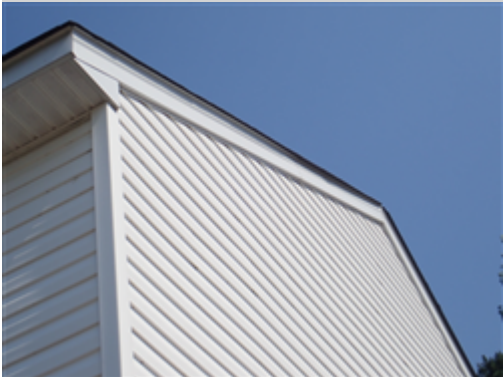
(C2 - 1.4) Main House

This home does not have a system such as gutters to control roof drainage. Direct drainage from the roof can result in direct water penetration into the foundation area and foundation deterioration. It is recommended that a gutter system with extended downspouts be installed to protect the wall cladding and foundation areas of the home. A licensed general contractor should be consulted for evaluation and installation.

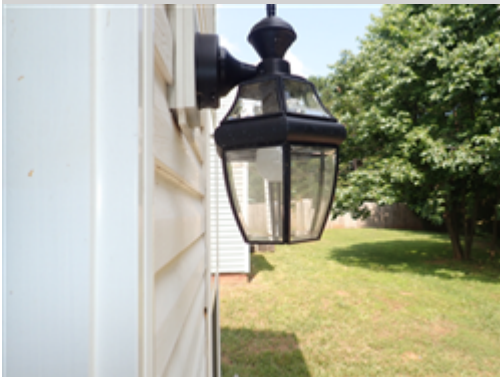
(E5 - 1.1) Exterior / back deck light

The light fixture located at the back door on the deck was not functional when tested. This could indicate a defective bulb or other more serious problem such as faulty wiring or a defective fixture. RECOMMEND change out bulb first, if still not working call A licensed electrical contractor should be consulted for further evaluation and repair.

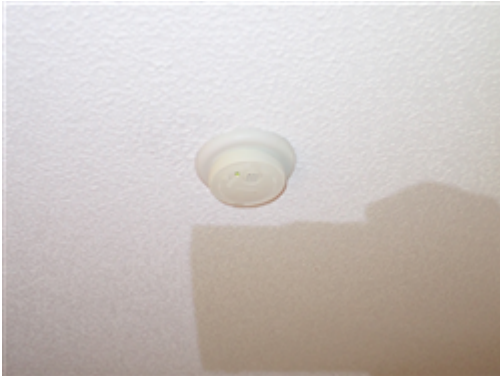
(E5 - 2.1) Family Room

The smoke detector was not tested because it was too high on the ceiling/wall and could not be reached. Smoke detectors should be inspected annually to ensure safe and properly operation. Verification is recommended

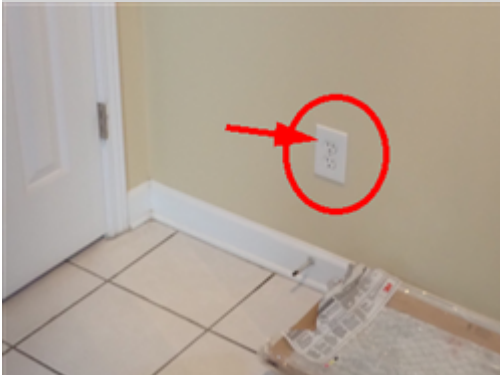
(E5 - 4.2) Foyer

The receptacle located in the foyer , the top plug is hard to plug into and required force to install. A hard to install receptacle plug could result in increased shock and fire hazards. A licensed electrical contractor should be consulted to make necessary repairs to ensure safe and proper operation and installation. All receptacles should be checked and replaced as needed.

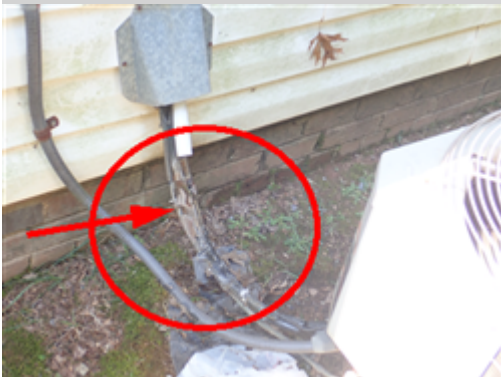
(G1 - 1.2) Cooling Unit #1 / BRYANT

The large line of the AC refrigerant line set that connects the outside compressor unit to the interior air handler is required to be insulated to reduce condensation and associated water damage. The AC line insulation is missing / damaged AND THE CONDESATE DRIP LINE NEEDS RE-DIRECTED AWAY FROM REFRIGERANT LINE. A HVAC contractor should be consulted for a evaluation and repair of the insulation on the refrigerant line on outside unit.

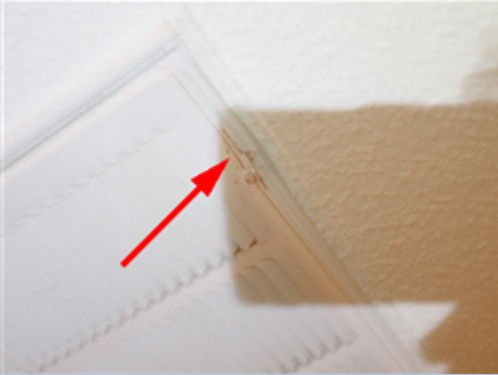
(H1 - 3.2) Hall

hallway upstairs return air vent grill is unlatched and looks damaged, return air vent should be shut secured to secure filter. recommend a general contractor to evaluate / repair.

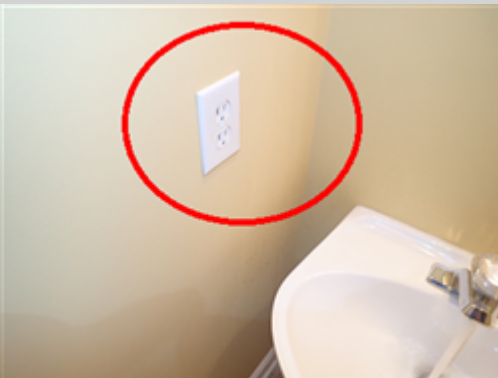
(H3 - 1.1) Half Bathroom #1/ DOWNSTAIRS

The electrical receptacle located downstairs in half bathroom are not GFCI protected. Receptacles located in hazardous or wet locations should be GFCI protected to reduce shock in hazardous locations. A licensed electrical contractor should be consulted for further evaluation and repair.

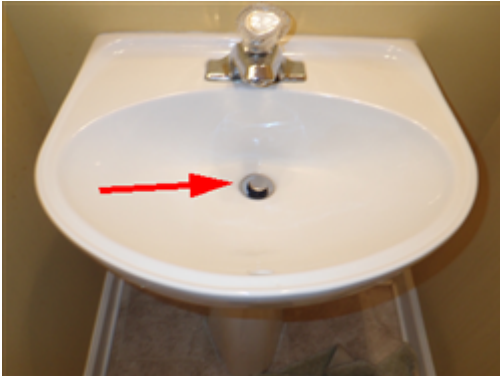
(H3 - 1.2) Half Bathroom #1/ DOWNSTAIRS

Downstairs half bath , the sink stopper will not seal properly, you cannot fill sink with water. A general contractor should be consulted for evaluation and repair to ensure proper operation.

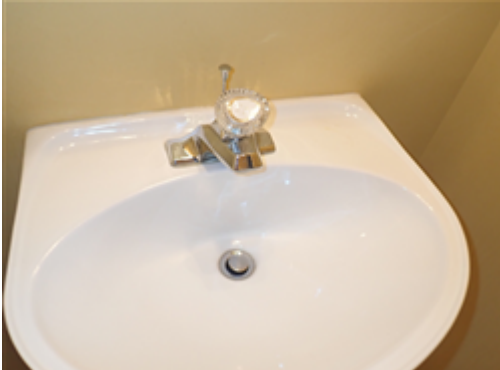
(H3 - 1.3) Half Bathroom #1/ DOWNSTAIRS

The hot and cold water supplies to the sink faucet are reversed from the typical positions of hot on the left and cold on the right. Reversed temperatures at the fixture can result in personal injury and can indicate an underlying problem. A licensed plumbing contractor should be consulted for evaluation and repair to ensure proper service.

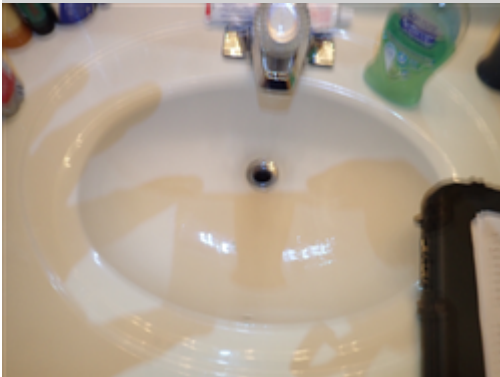
(H3 - 2.1) Bathroom: Master

Master bathroom upstairs is missing the sink stopper, you cannot fill sink with water. A general contractor should be consulted for evaluation and install of new stopper.

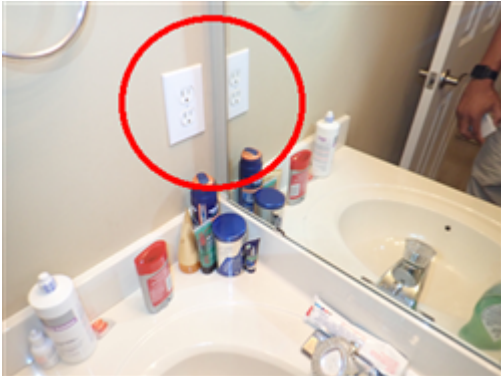
(H3 - 2.2) Bathroom: Master

The electrical receptacle located in the master bedroom are not GFCI protected. Receptacles located in hazardous or wet locations should be GFCI protected to reduce shock in hazardous locations. A licensed electrical contractor should be consulted for further evaluation and repair.

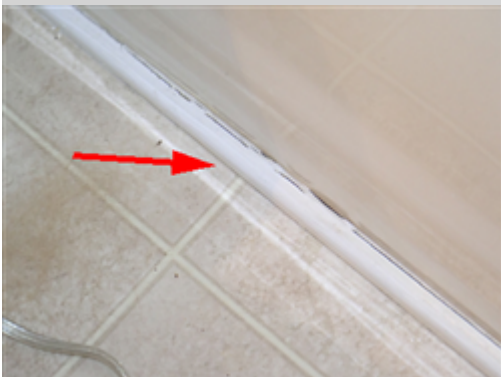
(H3 - 3.2) Bathroom #3 / hallway upstairs

missing sealant / caulking from floor trim to bathtub , overtime there will be movement from expansion and contraction to cause the openings, need to seal up the gaps to prevent water damage to the underlying floor, recommend a general contractor be consulted to evaluate / repair .

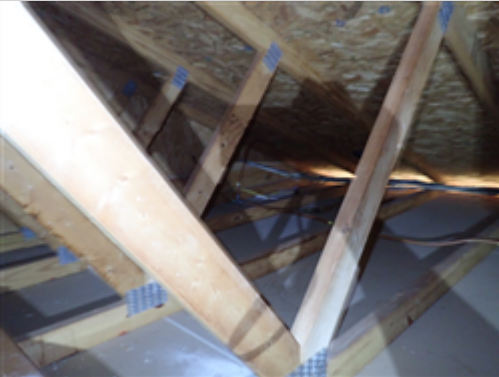
(H5 - 2.2) Garage: Attic: Unfinished

attic area above garage had several pieces of heavy wood material laying on ceiling obstructing my full view, seller mention he had a previous leak in that area that he has in a disclosure to the buyer, i noted no signs of moisture at this time in the area. recommend for client to read disclosure of mentioned leak and repair and if not fully satisfied recommend getting a professional roofer to come evaluate / repair.

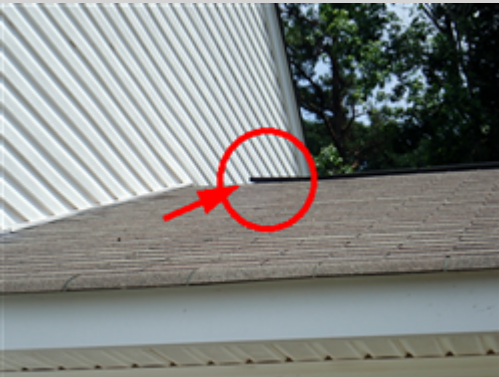
(H5 - 2.3) Garage: Attic: Unfinished

ridge vent above garage appears to be pulling away from roof, ridge vent not installed properly will allow water / insects/ birds to enter in to attic area and block proper airflow needed to keep attic properly vented . recommend a professional roofer to come evaluate / repair ridge vent .

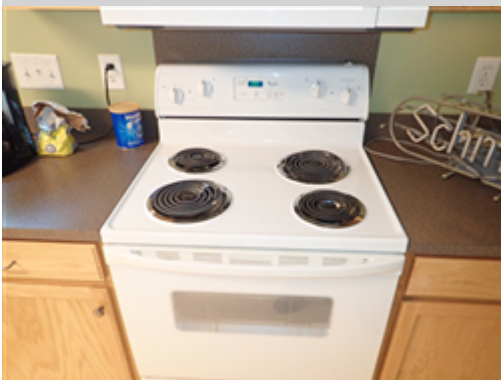
(J1 - 3.1) Oven: Electric

The oven/range moves forward when the door is opened. The oven needs to be secured anchored with an anti-tip bracket to prevent the unit from turning over when weight is applied to the door. An appliance repair person or general contractor should be consulted for repair.

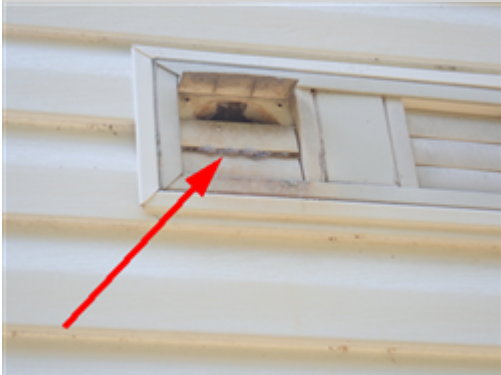
(J1 - 4.1) Vent: Dryer

The exhaust duct for the clothes dryer is clogged. The dryer duct should be kept in good working order to prevent fire hazards and properly distribute moisture to the exterior of the home. A HVAC / General contractor should be requested to clear out debris / lint in dryer duct for proper operation of vent.
