Property Inspection Report

Report Number: 10428

10428 Wilson Glen Drive
Charlotte, North Carolina 28214

Date of Inspection: Saturday, June 9, 2018

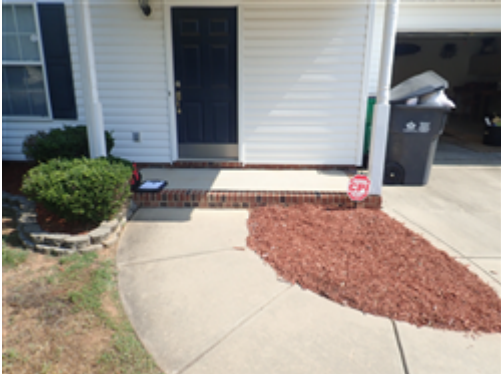
(B3 - 1.2) Porch

The columns that support the roof system of the home were noted to have areas of decay on both columns at the bottoms area. Columns and post are required to be stable to properly transfer loads to the foundation or footings. A licensed general contractor should be consulted for further evaluation, to determine the extent of the concern, and make necessary repairs.

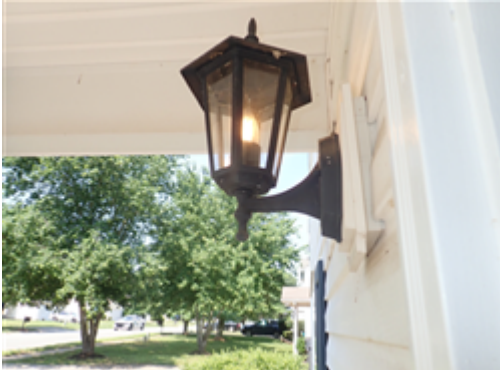
(B3 - 1.6) Porch

The electrical receptacle located on the front porch is loose. Loose receptacles could result in electrical shock hazard or property damage. A licensed electrical contractor should be consulted for a complete evaluation to determine the significance of this concern and make necessary repairs to correct defects and prevent safety hazards.

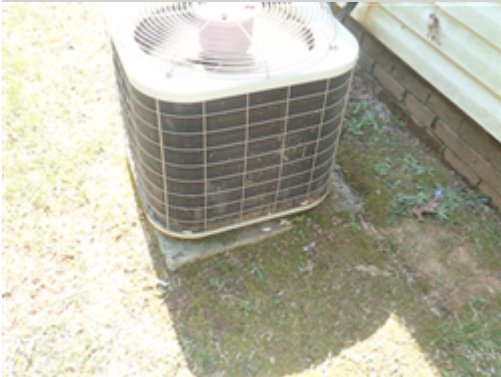
(G1 - 1.1) Cooling Unit #1 / BRYANT

The large line of the AC refrigerant line set that connects the outside compressor unit to the interior air handler is required to be insulated to reduce condensation and associated water damage. The AC line insulation is missing / damaged AND THE CONDESATE DRIP LINE NEEDS RE-DIRECTED AWAY FROM REFRIGERANT LINE. A HVAC contractor should be consulted for a evaluation and repair of the insulation on the refrigerant line on outside unit.

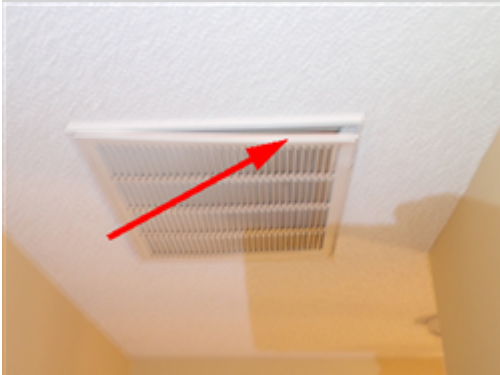
(H1 - 3.1) Hall

hallway upstairs return air vent grill is unlatched and looks damaged, return air vent should be shut secured to secure filter. recommend a general contractor to evaluate / repair.

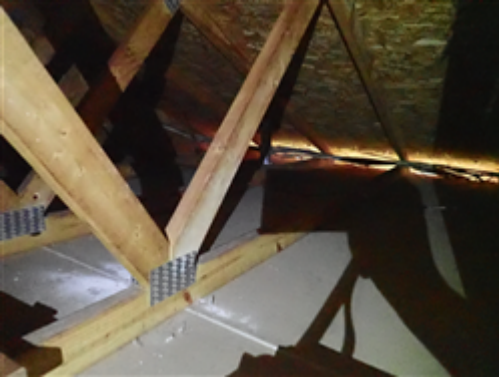
(H5 - 2.1) Garage: Attic: Unfinished

ridge vent above garage appears to be pulling away from roof, ridge vent not installed properly will allow water / insects/ birds to enter in to attic area and block proper airflow needed to keep attic properly vented . recommend a professional roofer to come evaluate / repair ridge vent .

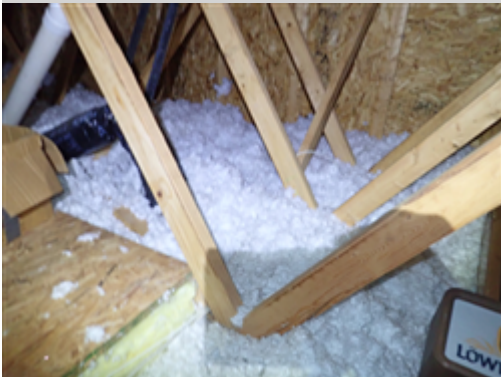
(I1 - 1.1) Attic

No immediate defects or concerns were noted. The insulation in accessible areas was inspected for indications of defects/damage only and not insulation effectiveness or R value. Determining the energy efficiency of the home is beyond the scope of the home inspection. The inspection or determination of the absence or presence of insulation in concealed areas such as wall cavities is not possible. Insulation is not moved in the attic areas. Insulation is moved in the crawl space or foundation areas where plumbing drain/waste pipes penetrate floors, adjacent to earth-filled stoops or porches and at exterior doors when conditions are not hazardous. The presence of insulation prevents the inspection of the ceiling, roofing, and floor components that are concealed or covered. Defects in the insulation system can lead to air infiltration, condensation, and elevated operational costs. The adequacy and proper function of ventilation systems depend on design specifications that cannot be verified during a home inspection. Inspection procedures related to ventilation involve identifying defects present on systems and components located in the ventilated areas. Active defects such as winter attic condensation will not be visible during the summer inspection unless the condensation has stained or corroded adjacent materials. Therefore the inspection of ventilated areas should be considered seasonally dependent, and the buyer should request a second inspection when the seasons change.

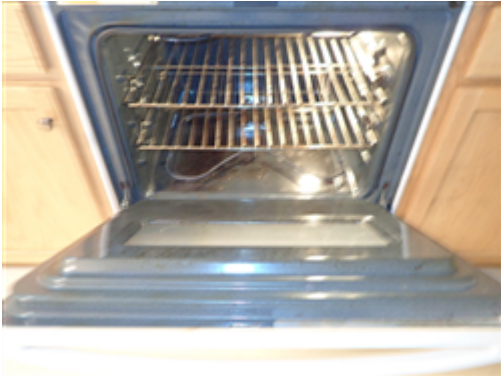
(J1 - 3.2) Oven: Electric

The oven/range moves forward when the door is opened. The oven needs to be secured anchored with an anti-tip bracket to prevent the unit from turning over when weight is applied to the door. An appliance repair person or general contractor should be consulted for repair.
